What Sank the RMS Titanic?

# Conclusions

and ask for NISTIR 6118, “Metallurgy  
of the RMS Titanic”, and the video  
“What Sank the RMS Titanic”

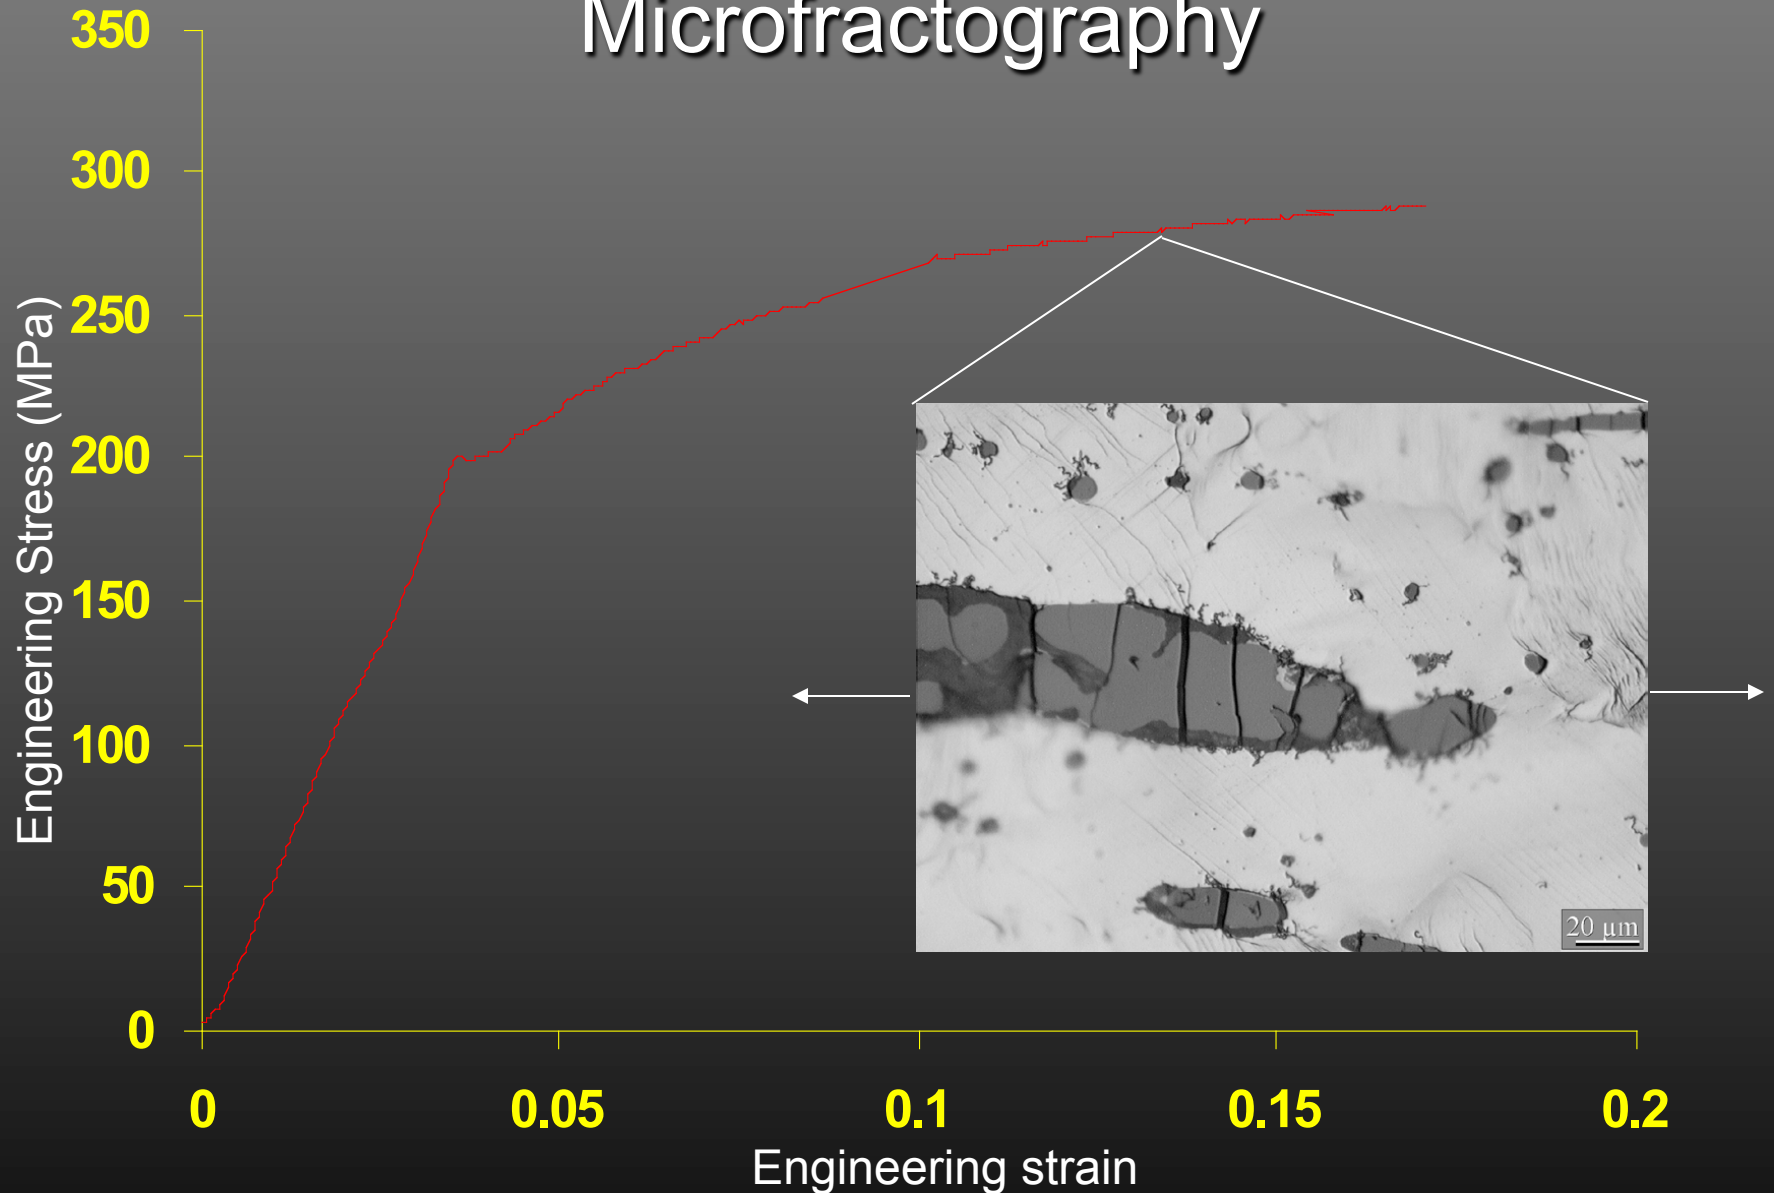
## Microfractography

# Fracture Strength of Slag

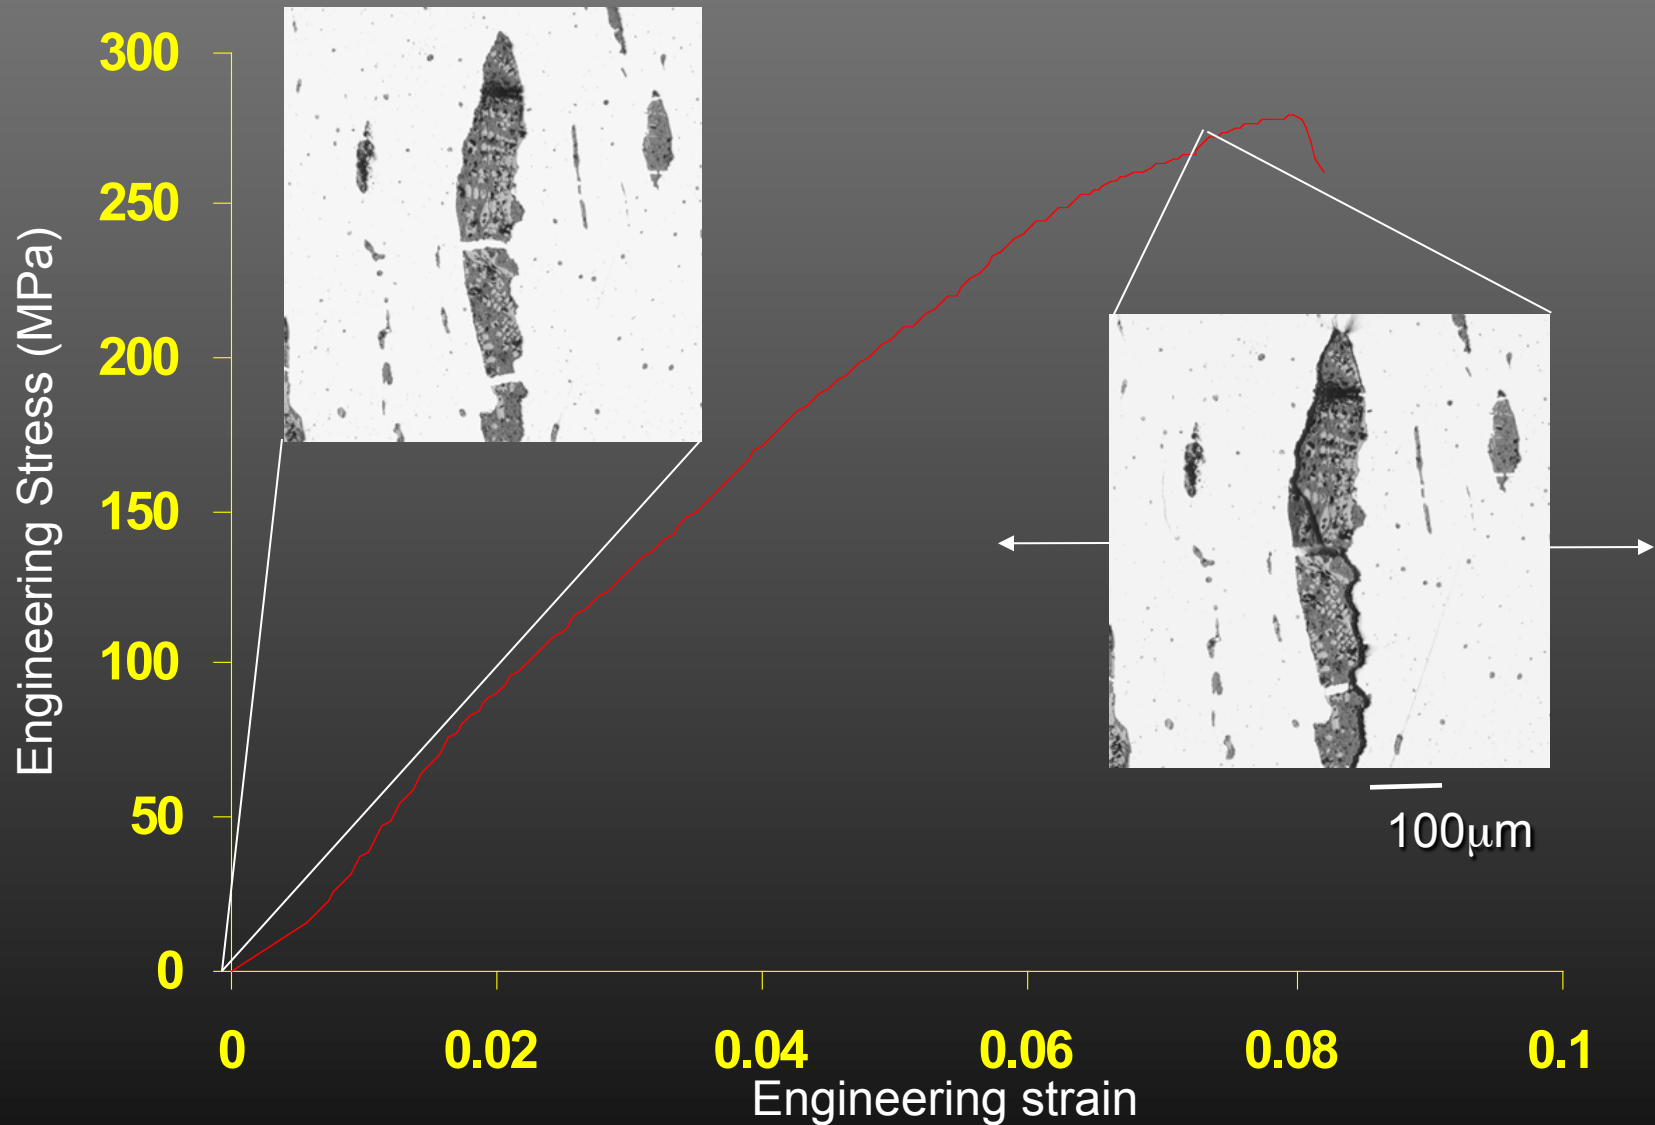
## Microfractography

# Slag-iron Interfacial Strength

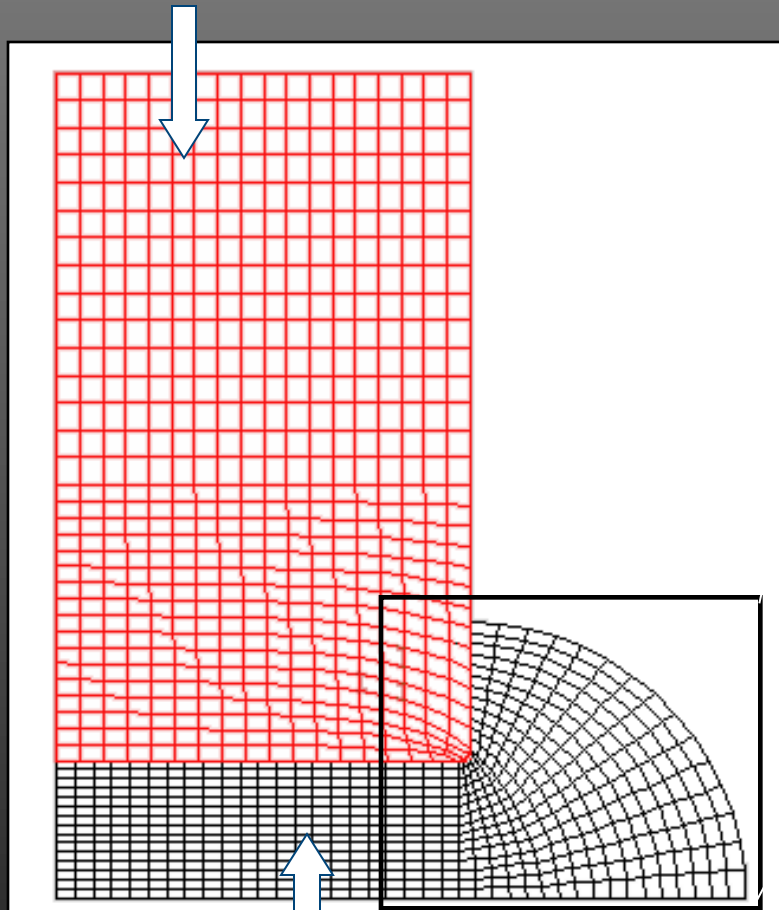
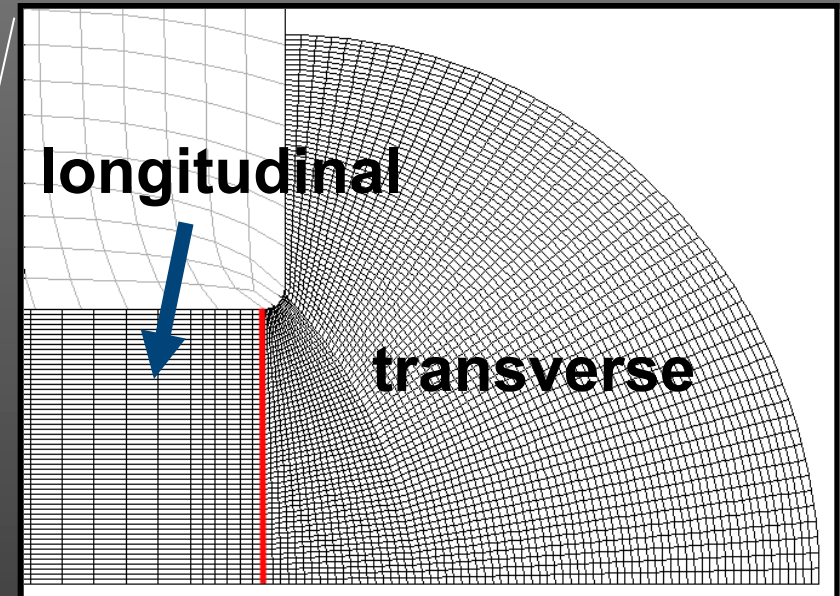
# Modeling of a Rivet

1018 steel plate

Wrought iron rivet

Thermomechanical analysis assuming an axisymmetric model about the tensile axis of the rivet, using input from tensile testing results

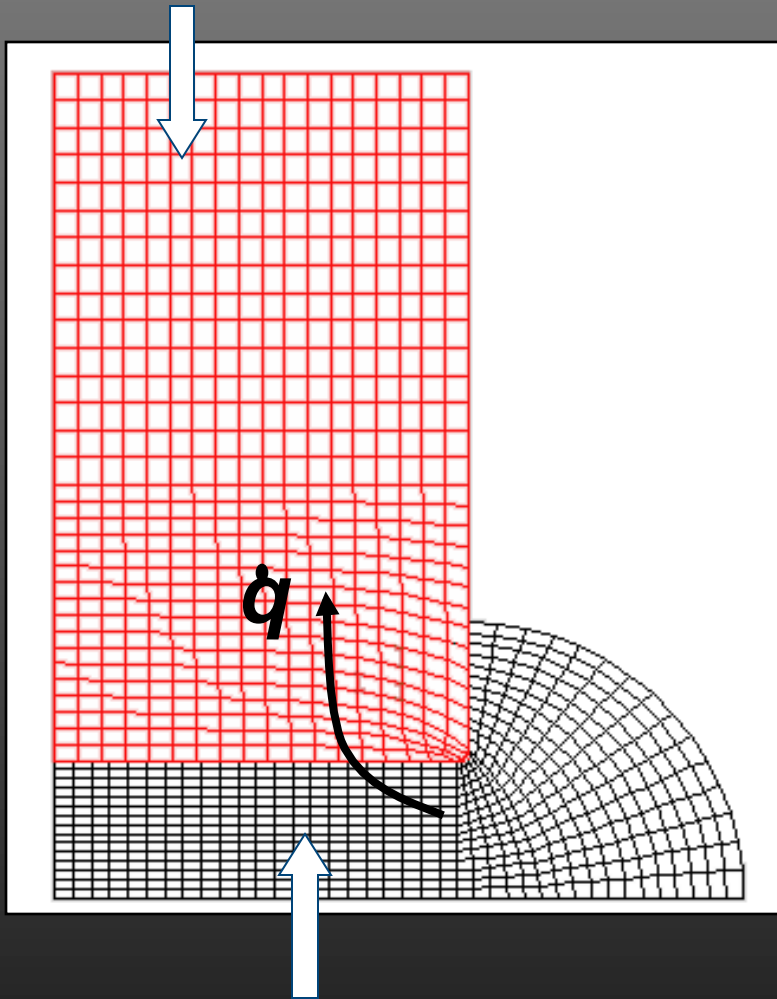
# Modeling of a Rivet

1018 steel plate

Wrought iron rivet

STEP 1:  
Extent of residual stress  
Cooling of the rivet from  
400°C to 25°C

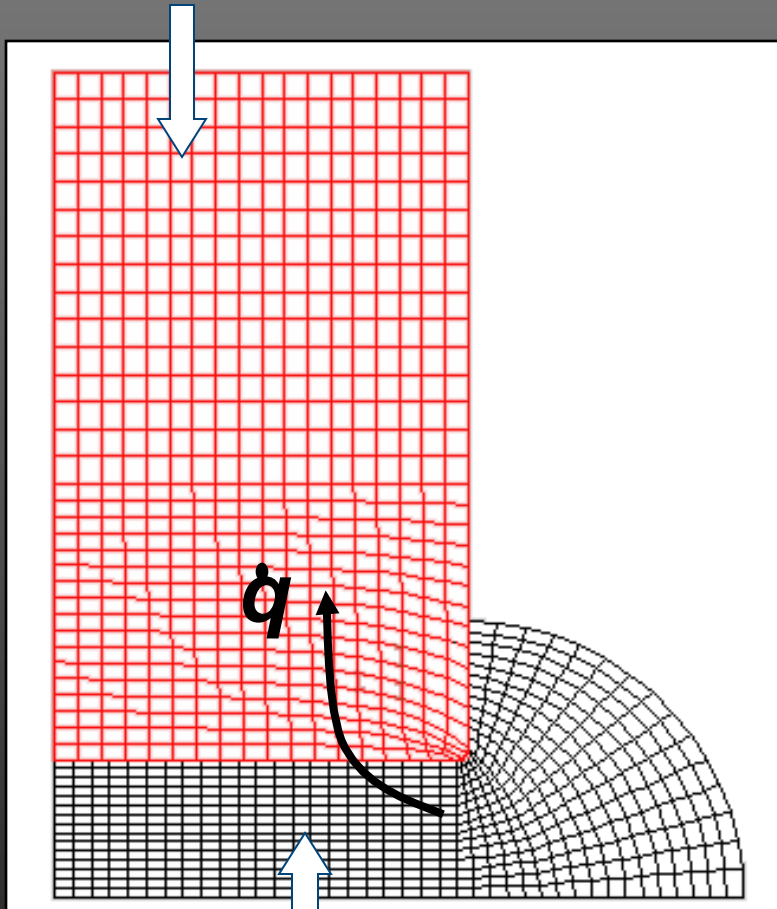
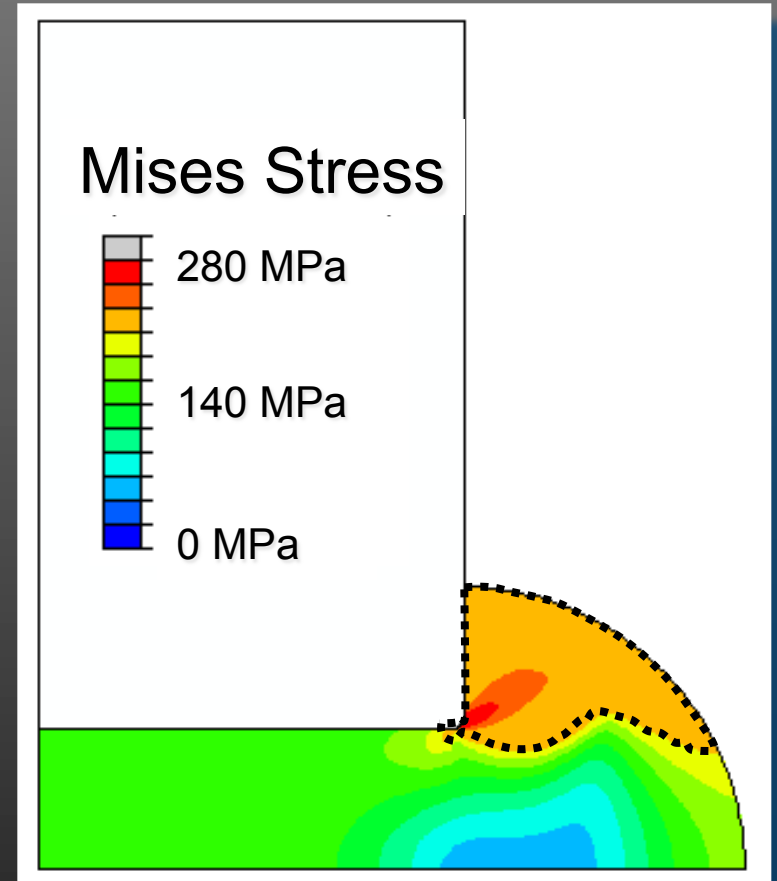
# Modeling of a Rivet

1018 steel plate

Wrought iron rivet

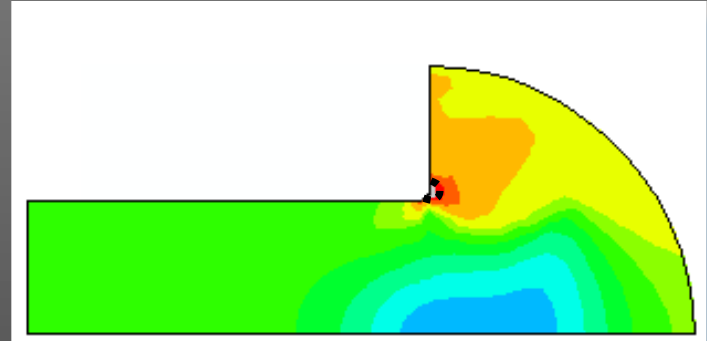
Isotropic steel

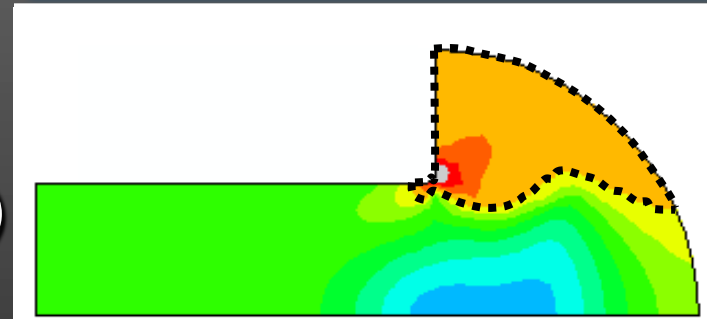
Isotropic iron  
(only longitudinal)

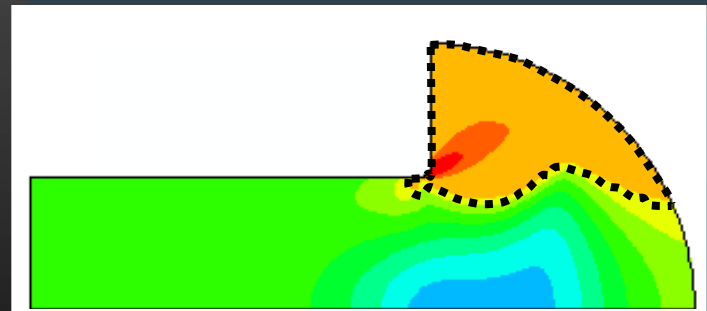
Anisotropic iron

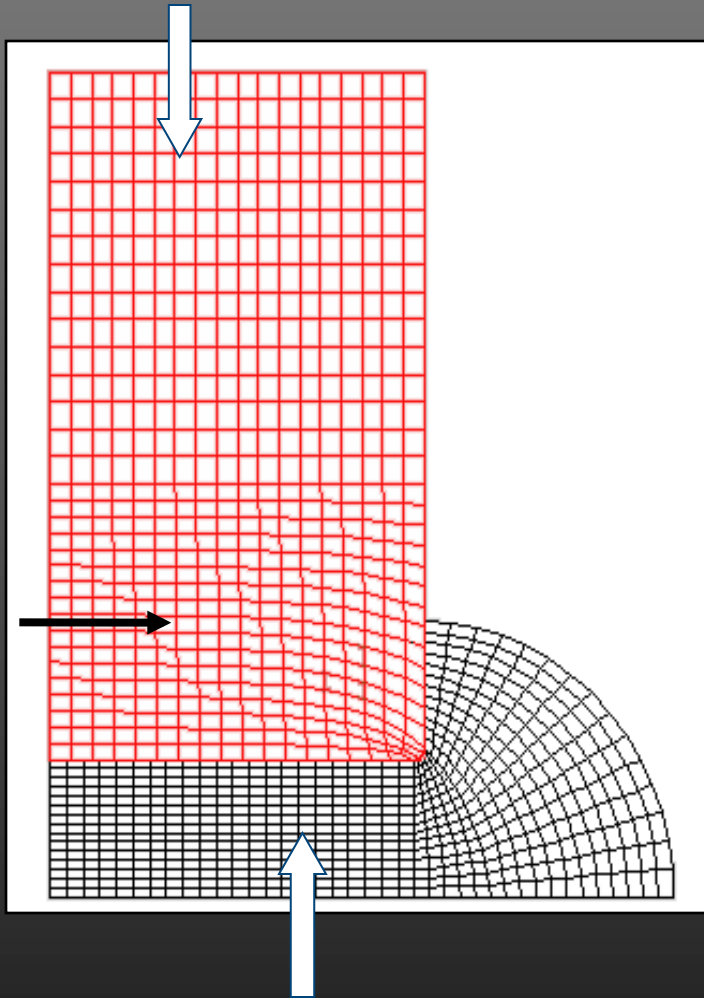
# Modeling of a Rivet

1018 steel plate

Wrought iron rivet

STEP 2:  
Stress due to loading  
Displacement of the plate

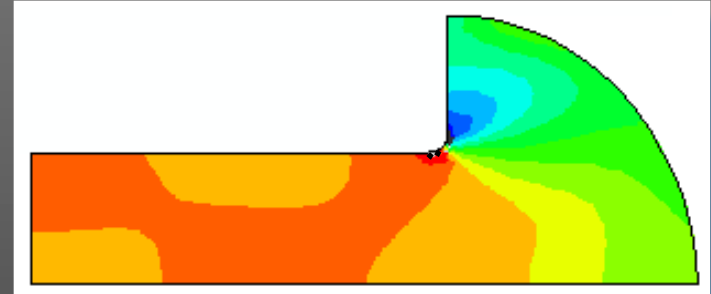
Isotropic steel

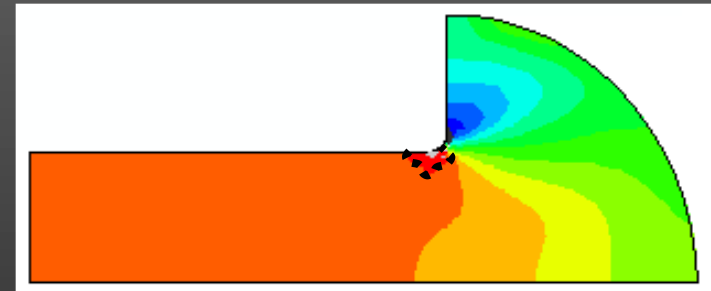
Isotropic iron  
(only longitudinal)

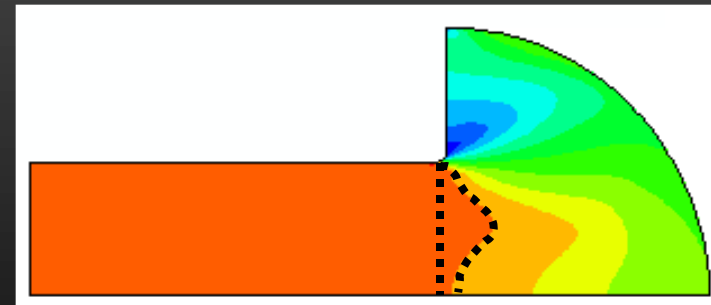
Anisotropic iron

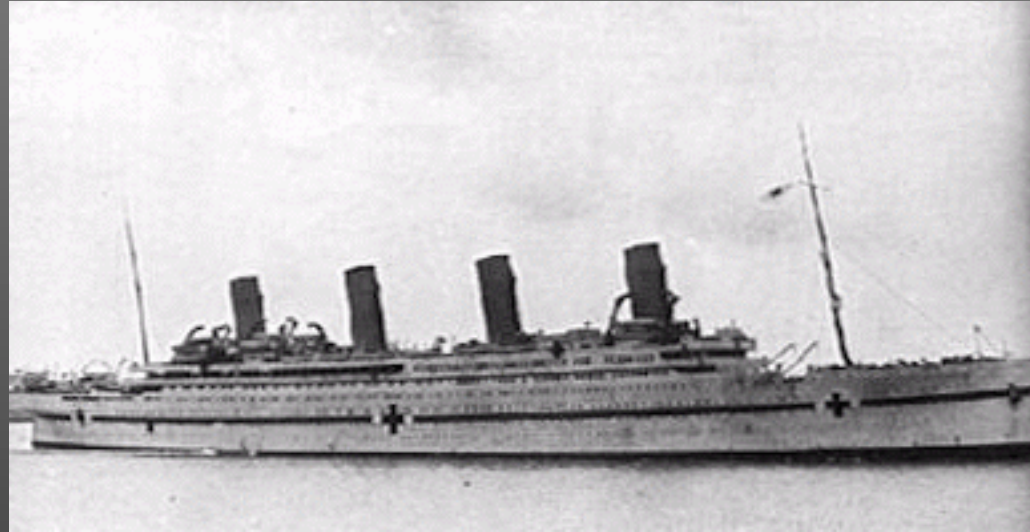
# Consider further HMHS Britannic

- Re-designed in the ways
  - complete double hull
  - higher watertight bulkheads
  - better watertight door controls

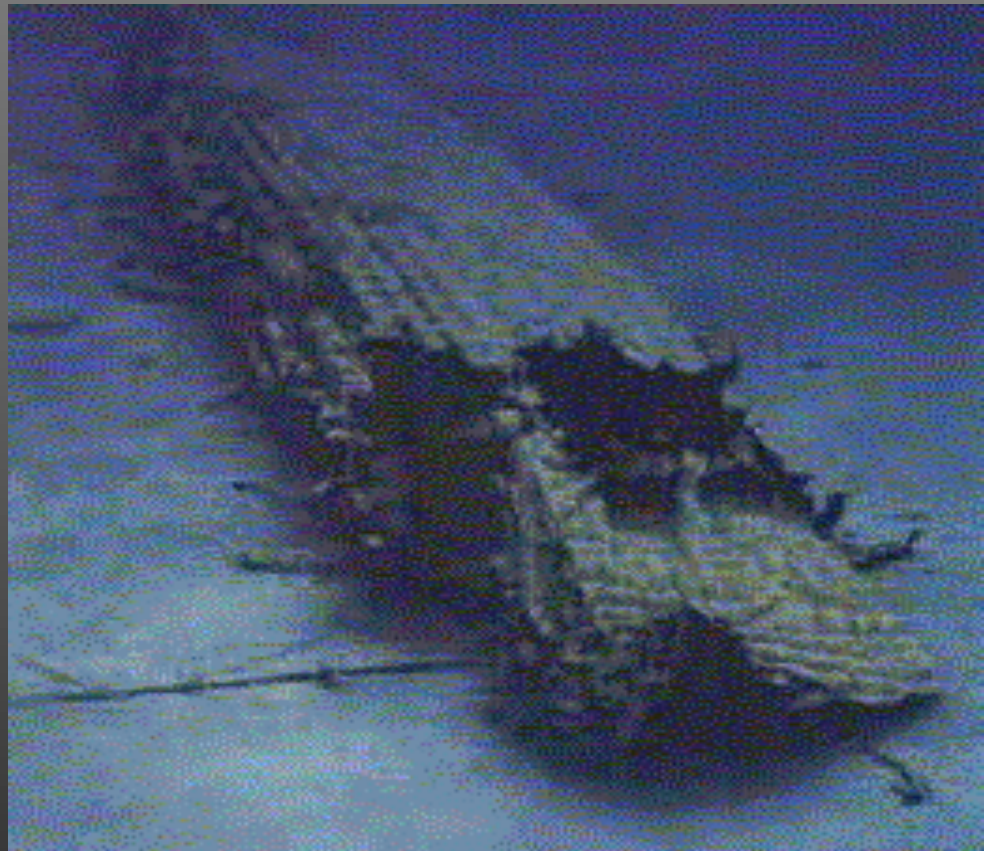
- Was commissioned a hospital ship in 1914
- Was making her 6th run to the Crimea when she was mined
- 40 foot diameter hole in her port bow opened two compartments

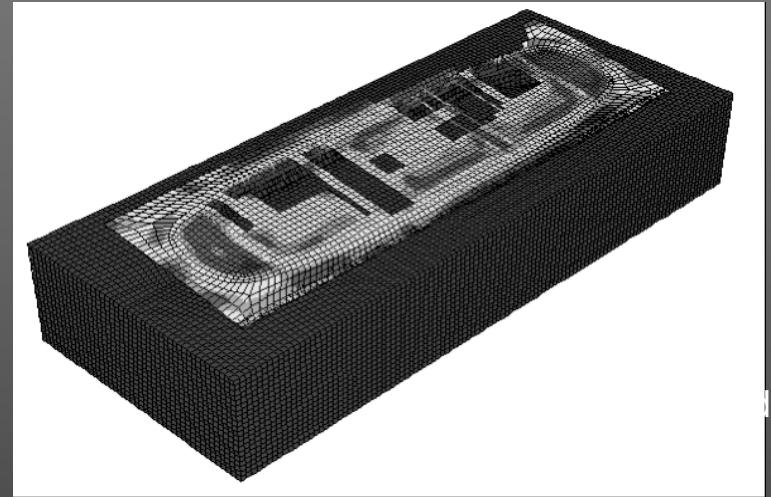
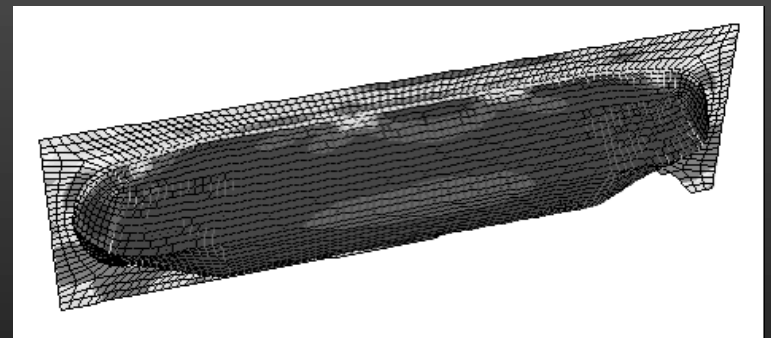
Ellis Island Ferry

- We calculated stresses under different salvage scenarios - found that mud is holding it together
- Based on our data, National Park Service has decided to leave wreck alone and preserve pieces
- Techniques learned in treating mud being applied to conservation of wreck of *USS Arizona* (funded by US Navy and US Park Service).
